Report for the
Restoration and Renovation of the
Cascades
at Sparks Foundation Park

June 13, 2012

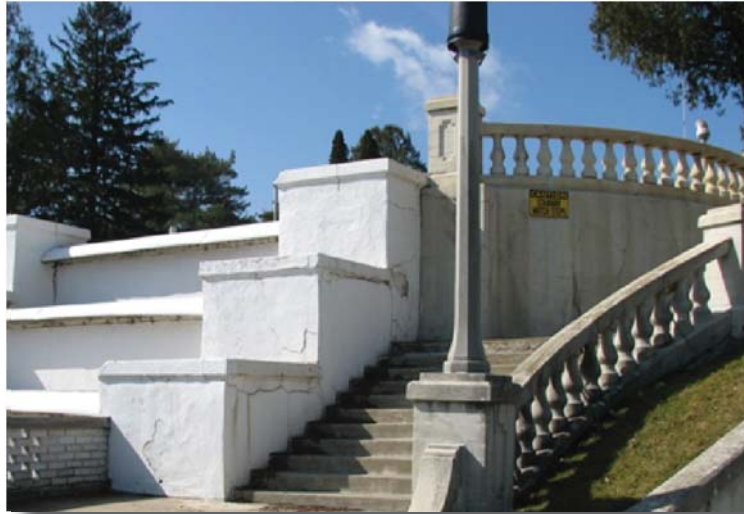
Flower Boxes, Curved Walls, and Railings

One of the major components of the Cascades is the three-step waterfall with a curved pool. At each end of these three curved pools is an approximately 8-foot tall curved retaining wall. Repairs have been attempted on these curved walls twice in the past – first with a fiberglass patch in the 1970s, and again in the 1990s with a steel mesh and gunnite surface. Gunnite is a spray-on material with limited structural properties, and is mainly used for patching and resurfacing.

Rebound hammer tests on the gunnite indicated a strength of about 7,800 pounds per square inch (psi), actually stronger than typical concrete. However, the surface of these gunnite repairs has “map cracked” and is very aesthetically unpleasant. More vital than aesthetics is the detrimental effect this gunnite repair is having on the remaining structural reinforced concrete. By forming an imperfect barrier in front of the original concrete wall, this gunnite repair is both letting moisture in and keeping it from escaping – the original wall is continually deteriorating from this moisture and is unable to “breathe”. In a few locations, chipping through the gunnite revealed a concrete wall that has literally crumbled.

In our experience, walls of this age and with this type of deterioration are very difficult (if not impossible) to patch and repair. The best course of action, in our opinion, would be to completely demolish these six curved walls and install new reinforced concrete walls matching the original design.

Adjacent to these curved walls is a stairway and a set of planter boxes. Because of the extent of the work required to replace these curved walls, it would be cost-effective to remove and replace both the stairs and planter boxes at the same time as the curved walls. Additionally, a large portion of the stair treads are cracked and delaminated – replacement would bring them back to original condition. The same is true for the planter boxes. Several large cracks are present on most of these boxes, and replacement is likely the best course of action to obtain an extended lifespan.

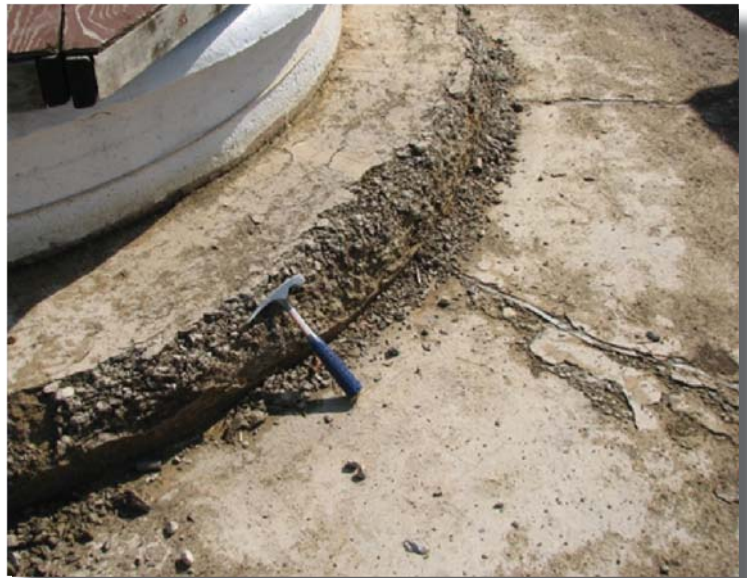
Concrete Deterioration at Upper Pool

Another element of the structure that we are recommending complete replacement of is the upper pool. Based on our evaluation and the existing documentation, it appears as if this upper pool is still the original concrete. Sounding indicated numerous delaminations and significant spalling. In addition, there are numerous large cracks throughout the entire 6” thick slab. Much of the water lost during the operating season is likely lost through poor concrete like what is found in this upper slab. Given the relatively shallow depth of this concrete, repairing the surface is not likely feasible, leaving replacement as the best option. Not only will this return the structural integrity to this upper pool, replacement will also reduce water loss and reduce the need for surface coating work, which will be discussed next.

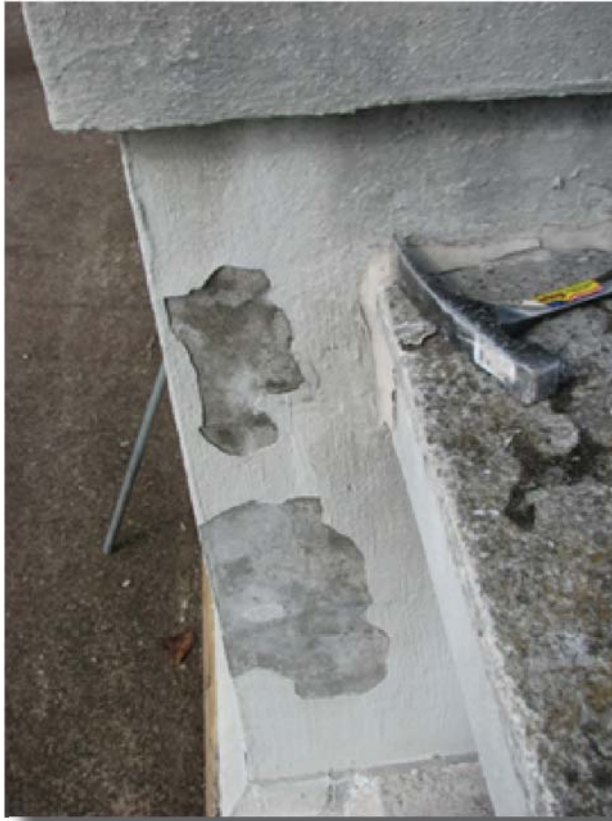
***Existing Concrete Coating,
Failing in Numerous Locations***

Based on our field observations, it appears that the surfaces of most of the railings and other concrete have been coated with a thin cementitious material. In many locations, this is flaking off, giving a lot of the structure an unpleasant appearance. We are recommending that the entire structure be high-pressure washed, removing all of this remaining coating. With that complete, a full structural assessment could be made to the remaining concrete, any necessary surface repairs completed, and the entire structure could receive a new, advanced, and breathable concrete coating, which would both prolong the life of the structure and improve aesthetics

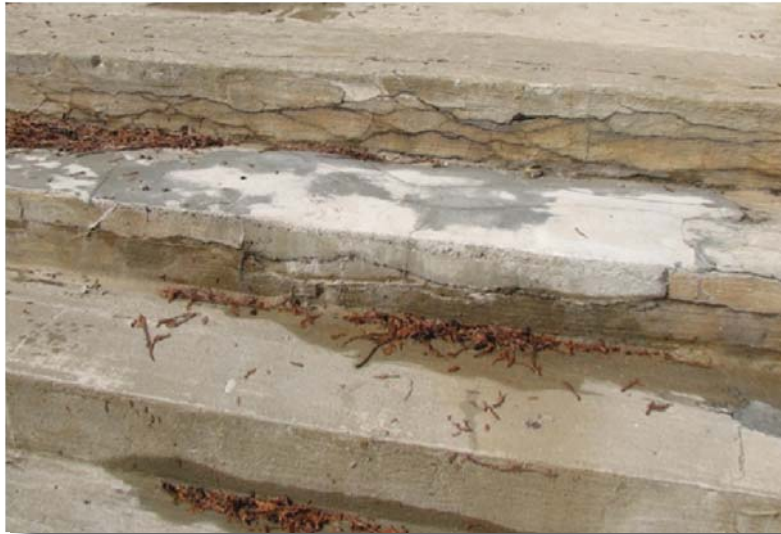
It was noted during one of the site visits that the stair treads become slippery during operation. Water from the pools leaks onto the stairs and spray from the Cascades is windblown onto them as well. Spicer has used nonskid coatings in the past, and we would recommend that all of the stairs throughout the structure receive this nonskid treatment. Prior to doing this, a full assessment of the structural integrity of the stairs needs to be completed and any stairs needing repair should be either fully replaced, or if possible, have a deep surface repair completed. This would again drastically improve aesthetics, as well as provide a safe environment for patrons well into the future.

Deterioration of Stairs, Common at Numerous Locations

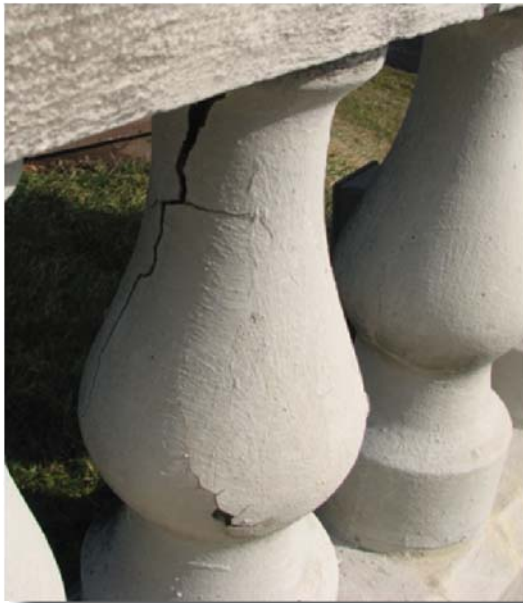
A major feature of the Cascades is its ornamental baluster railing system. This consists of concrete upper and lower rails with concrete spindles (balusters) in between. These have been present at the Cascades from its original completion, and add a very decorative, ornamental touch to the entire structure. Unfortunately, time has taken its toll on many of these spindles.

Cracked Concrete Spindles, Scattered Throughout Structure

lifespan of this repair work, we would recommend fully replacing any spindles exhibiting cracking or spalling. At this date, we are estimating that 120 spindles will need to have

replacements cast and be replaced. In addition, approximately 600 spindles will likely need to be removed, salvaged, and reinstalled as part of other structural work being done.

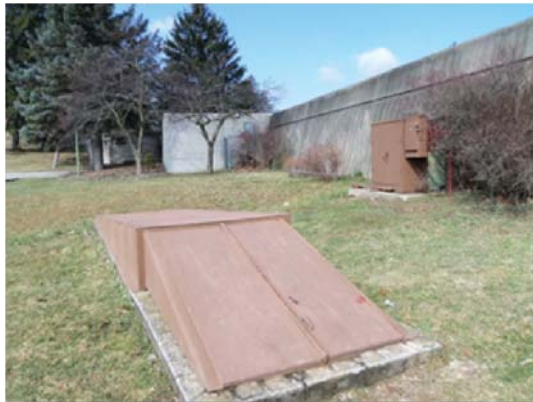
Entry Point to Underground Mechanical Room

With the exception of the well pump, many primary equipment and components (listed below) are located in an underground room, which is a significant safety risk. First, this room and stairwell leaks groundwater and the old electrical components installed in this damp and wet environment are not rated for this type of environment, so the electrical hazards in this environment are severe and not compliant with current code. Second, this underground room is a confined space and further has only one means of ingress/egress. This means that per current OSHA standards there are risks of entrapment, flooding, electrical hazards and inadequate ventilation for chemical storage for which the employer is fully liable. Guidelines require multiple staff members to be trained and follow specific procedures for confined space entry.

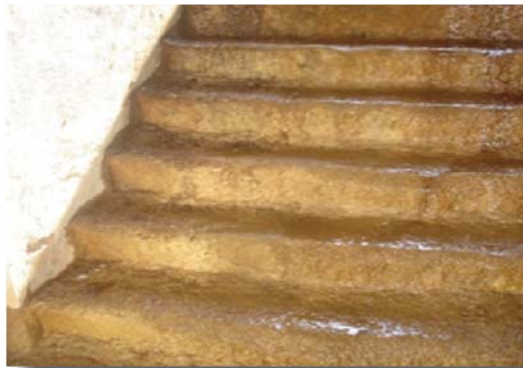
Wet, uneven, failing existing stairs

In general, a single person should not enter this room alone. Third, there is limited space between equipment – in many situations, staff must step across equipment and piping, which is also a compliance and liability issue for the County. Finally, the existing stairs are a trip hazard. Staff must enter this room down stairs that are wet, uneven and crumbling, with no skid protection.

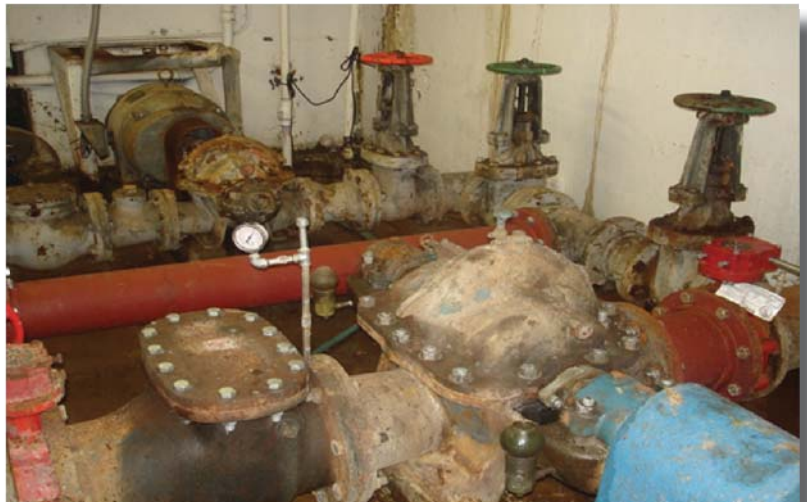
System and component conditions have deteriorated due to sheer age, intermittent use and resultant corrosion. The operations staff has done an excellent job of keeping things functional, but the systems are very labor intensive to operate and prepare for operation annually. Given current budget levels, preventative maintenance and gradual parts replacements have

Aged mechanical equipment in underground vault

Having all of the critical equipment required for the Cascades performance located in the unsafe underground room needs to be corrected. We recommend that the mechanical and electrical equipment be replaced and relocated above ground in a new

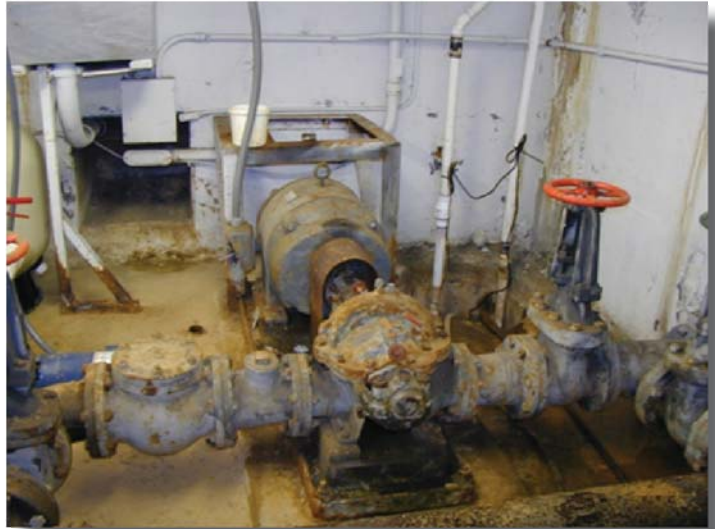
- The main pump is the original pump from 1930s and is rated for 2000 gpm. This capacity pump gives the desired performance of the jets and water flow over the Cascades. This pump was out for service during our initial inspection. The pump had a new shaft, packing and inner rings replaced. The main pump is used to transfer water up to the top of the Cascades to spill down the Cascades, and serves as the main water flow in the Cascades.

Location of original pump from 1930s

1. This new building would have a new main and back up pump of equal size to provide true redundancy for the pumping system with more efficient motors for reduced electrical usage.

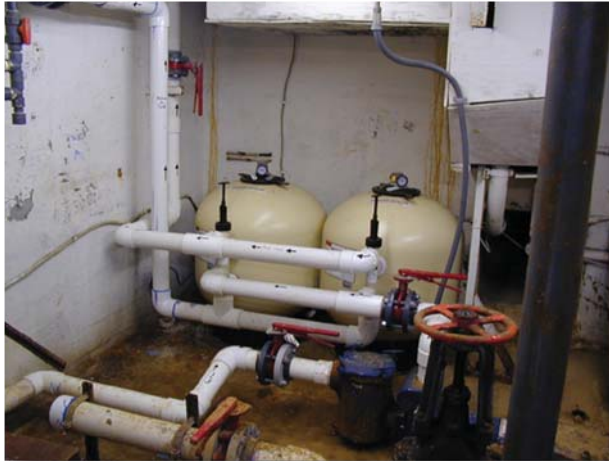
- Chlorine is fed to the water at a minimum of 15 gallons per day to help prevent algae and biological growth in the pools. Higher concentrations of chlorine would be preferred as it would help with corrosion control, but chemical usage has been limited due to budget restraints. Liquid sodium hypochlorite is used and is delivered weekly in 150 gallon increments. The chlorine is currently fed into the filtered water line that returns to the storage tank. There are no issues with the tank or metering pumps and they can continue to be used; however, the space is not properly vented for chemical storage as there are not enough air changes in this room to provide enough fresh air for occupancy by personnel. Again, this is a risk management and liability issue for the County.

Chlorine storage and feed area

3. Chlorine would continue to be used to prevent algae growth and with the iron removal system may be more effective at the lower concentrations due to the reduced levels of minerals that can consume the chlorine in the water. The feed point for the chlorine may change to only chlorinate the water as it is pumped to the Cascades. The existing chlorine system and filter system would be relocated to the new building to manage costs, as this is one of the few components that is salvageable.

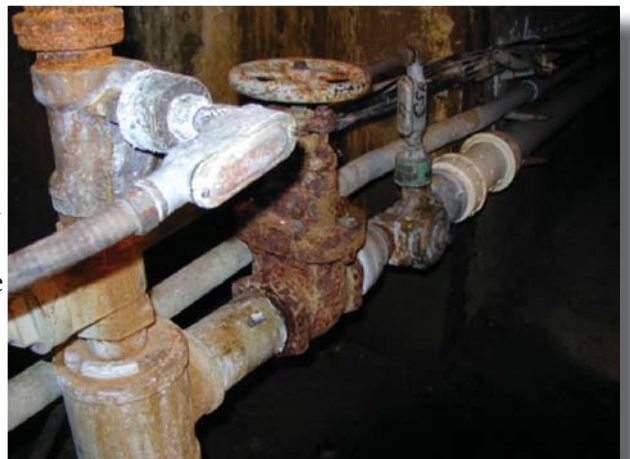
- Tunnel pipe and valves have corrosion throughout, and some of the valves are not functional. It is expected that there is significant internal pipe corrosion given the high iron content of water and with the intermittent operation of the system, that water is allowed to sit in the pipes and continue to develop scaling and obstructions. Over the years, the effective pipe diameter would be significantly reduced.

Severely corroded tunnel piping and valves

The existing tunnels would be used solely for the piping and electrical component replacement. The piping and valves in the tunnels would be removed and new lines would be routed in the tunnels, up through the concrete and into the fountains where the existing fixed components would be cleaned and reused. The three existing tunnels would be opened up on the south end in order to install the new piping. Access hatches and steps would be added so that the piping can more safely be accessed in the future if needed. The second access point also improves the safety for staff to access these areas by improving ventilation and having a second point of entry. It would not be necessary to enter the tunnels for any normal maintenance or operational activities.

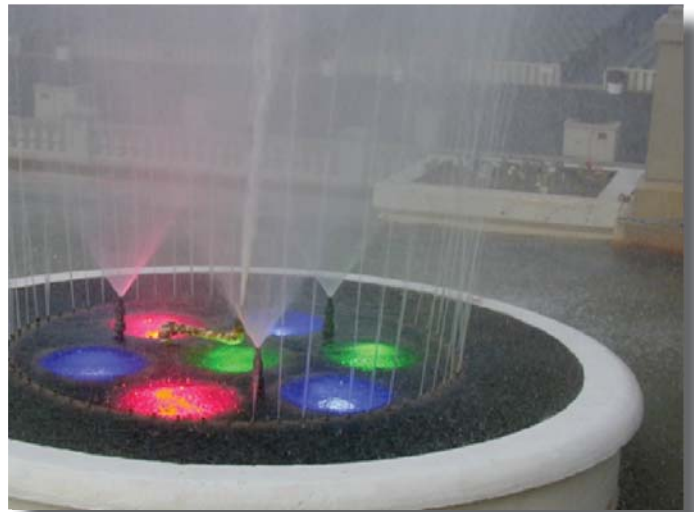
- The nozzles, foggers and center jets in the fountains are not currently able to function independently with the solenoid valves out of service. Anecdotal evidence suggests that the fountains may have sprayed to a greater height in the past. The Parks Department has indicated that they would like to maintain the current performance as far as flow and height of spray, but would also like to re-establish the ability of independent component and independent fountain operation for the shows. The nozzles, foggers and center jets are fixed components that could continue to be used with some chemical cleaning, especially for the brass nozzles. This cleaning may result in improved spray performance.

Fountain with clogged nozzles in left foreground

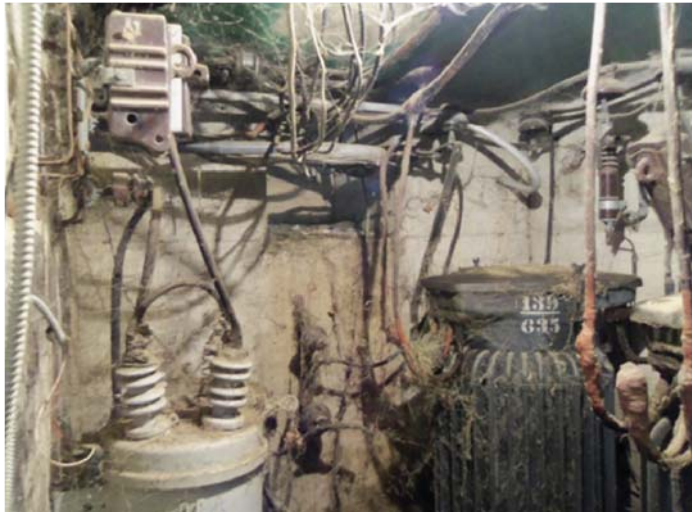
5,000 Volt gear in Vault

The electrical system is fed from a 5000 Volt (5000V) primary service. The 5000V feeder is an original cable system made of lead, typically used in the 1930s. This cable runs to the separate locations of the site providing local power via step down transformers at each site. The cable and its supporting gear are in poor condition, are no longer used in the industry, and are well past their useful life. Furthermore, very few electricians are familiar with this equipment.

We recommend that the existing electrical service be replaced with a new 480V service. This will allow all of the systems to be nominal voltages that are easily supported by any electrician and not require the special safety and operational constraints that come with medium voltage gear (anything over 600 Volts). This new electrical gear would be installed in the new mechanical building noted above, would support all of the needs of the complex and would be easily and safely accessible. This new gear would support the mechanical functions of the falls as well as the lighting, sound and controls. All of the electrical gear would be moved out of the tunnels and the tunnels would only be used for wiring and conduit to feed end use items such as lights.

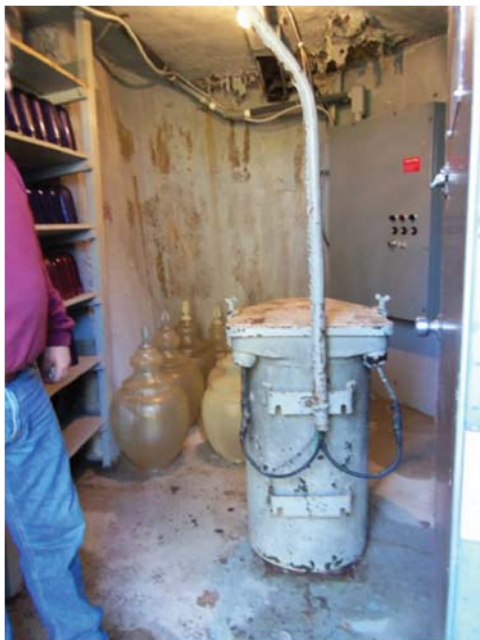
Step Down Transformer in wet vault under Cascades

There are locations throughout the site where there are exposed 5000V electrical parts in wet areas where operators have erected makeshift plywood barriers for safety and there are primary transformers with standing water underneath them. It is important to understand that the plywood barriers offer limited protection and are not compliant with current code. These conditions are a substantial liability to the County, are unsafe, and need to be remedied.

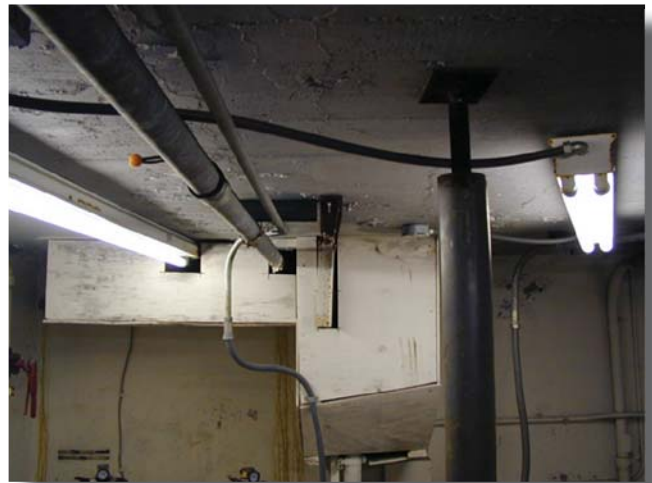
5,000 Volt connections covered by plywood

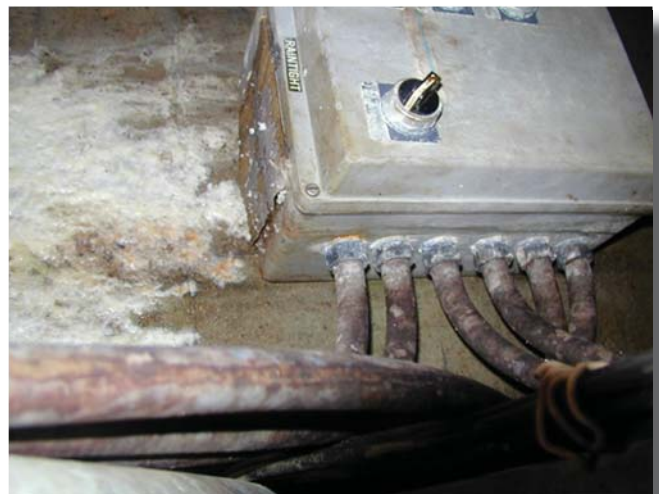
Corroded Electrical Equipment in Tunnel (Wet Environment Typical)

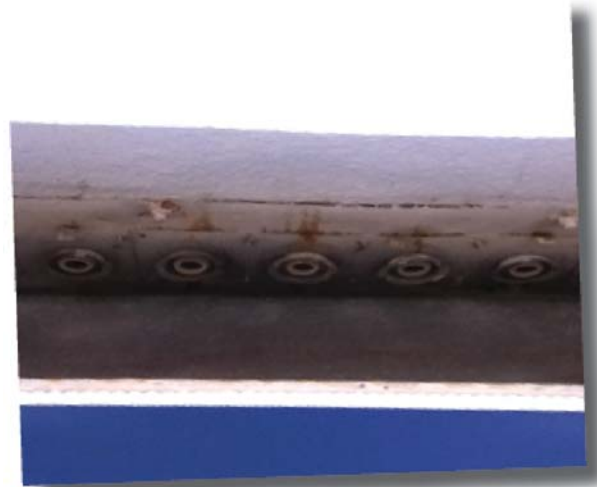
Light sockets under waterfall cap

These fixtures, while functional require significant maintenance and lamp replacement each season. We recommend replacing this system with a waterproof LED light fixture system. These LED fixtures would use roughly half the electricity and last 100,000 hours of run time. Furthermore, the LED fixtures would be mounted in groups on removable racks, dramatically reducing annual installation effort and reducing the quantity of incandescent breakage during installation and removal each year. The high breakage rate is due to the unusual configuration and tight access space to bulbs, along with the sheath for each bulb.

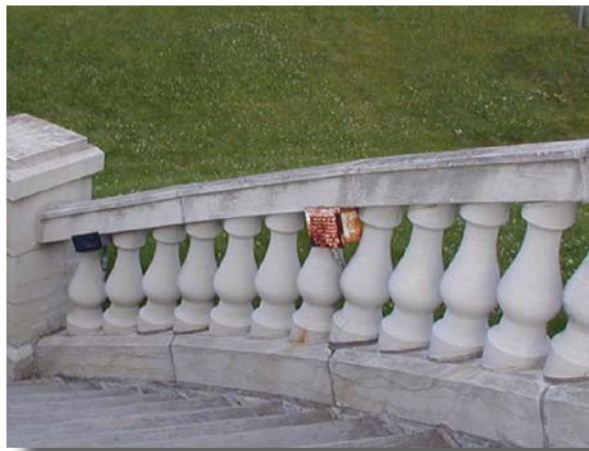
Corroded Stair Lighting

The stair lighting does not adequately light the stairs and should be replaced. The security lighting around the perimeter of the fence is an ungrounded mercury vapor system. These lights are dated, provide poor light rendition and have a dated look not matching the aesthetic of the rest of the falls site. We recommend that the existing decorative acorn fixtures be retrofitted with new energy efficient fixtures with the same style and look while reusing the poles.
