SECTION III • ANALYSIS

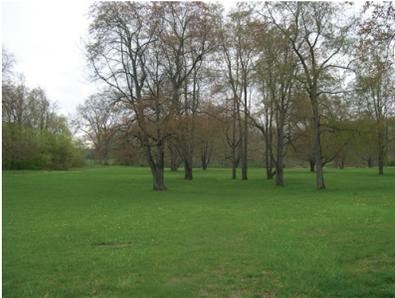
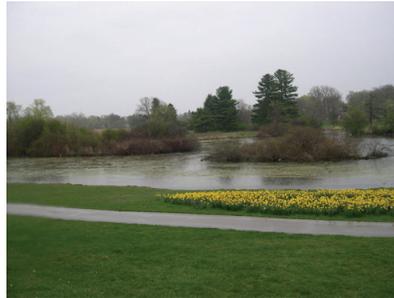
Cascade Falls is situated on a prominent landform and provides panoramic views to the surrounding neighborhoods. A second vista exists at the high point on Randolph Street and provides internal views to Cascade Falls, wetlands, canals, and ponds.

Over the last decade, the historic Paredo, the formal, landscaped promenade leading to Cascade Falls, and the contiguous canals, ponds, and footbridges have fallen into disrepair. The Paredo is currently overgrown with trees and shrubs, blocking the original sight lines to Cascade Falls from its easternmost terminus. The mowed fields have become too wet to maintain lawn and have converted to cattails and other emergent wetland species. Purple loosestrife, a highly invasive, non-native species, is prevalent through this wetland. The canals and ponds have water quality concerns (circulation) and are in need of sediment removal. Large algae blooms occur throughout the summer months. The arched bridges that crossed the canals in three locations have been removed.

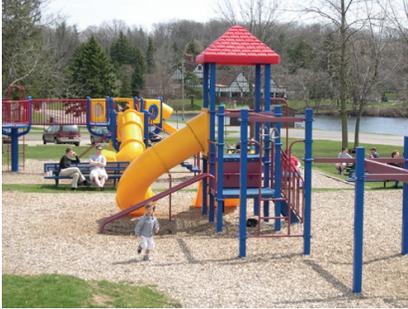
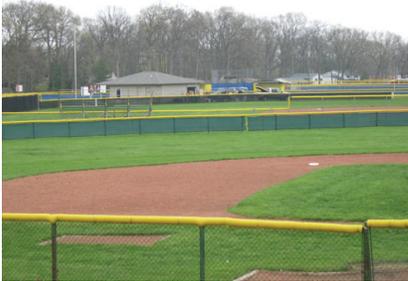
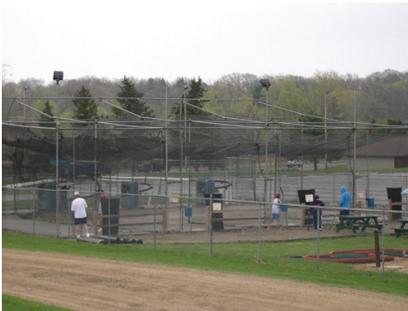
- The playgrounds are in great condition, and the adjacent ice cream concessions building continues to be a major draw of Park users.
- The spring displays of daffodil plantings along the path system are spectacular and contribute considerably to the curbside appeal of the Park.

- The little league fields are well maintained and are heavily used during the summer by teams throughout lower Michigan.
- The trails and boardwalks are in great condition and are heavily used for walking, jogging, and bicycling.

- Programming for special events continues to draw increasing numbers of users and often requires the closure of Brown Street to vehicles.
- The grounds are well maintained and mowed frequently.
