Report for the
Restoration and Renovation of the
Cascades
at Sparks Foundation Park

June 13, 2012

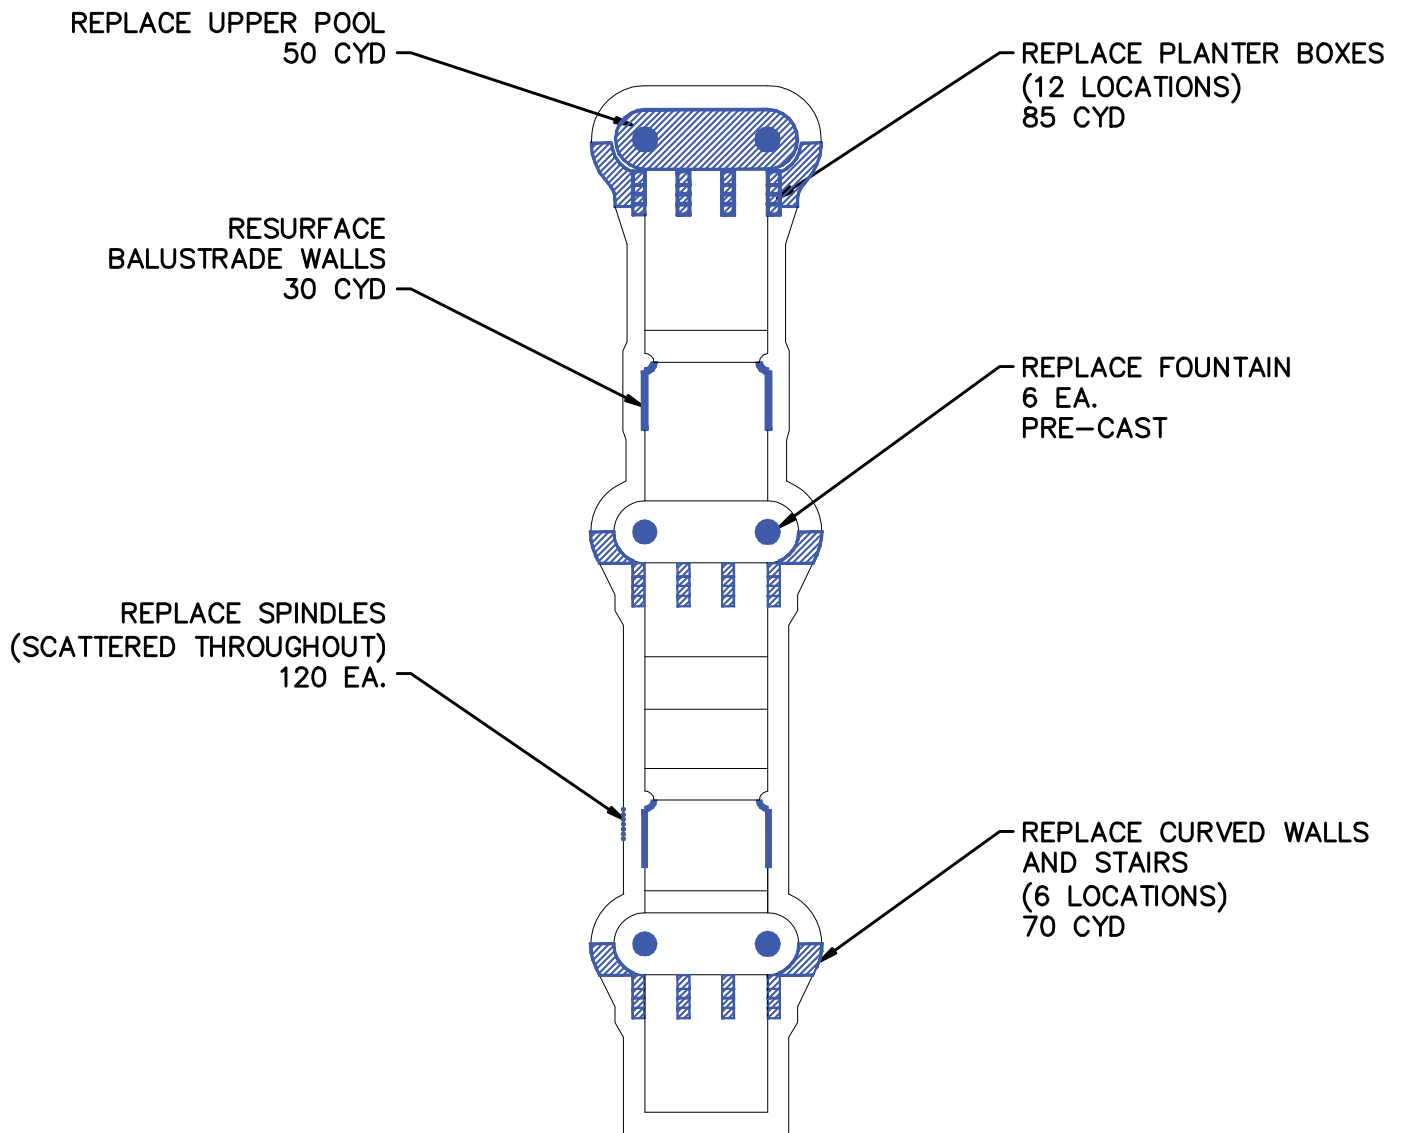
FIGURE #1

6. As noted in our Progress Update, there is major specialty concrete work required. On a positive note, based on your questions, we have determined that only about 20% of all concrete needs to be replaced, as shown in Figure 1.

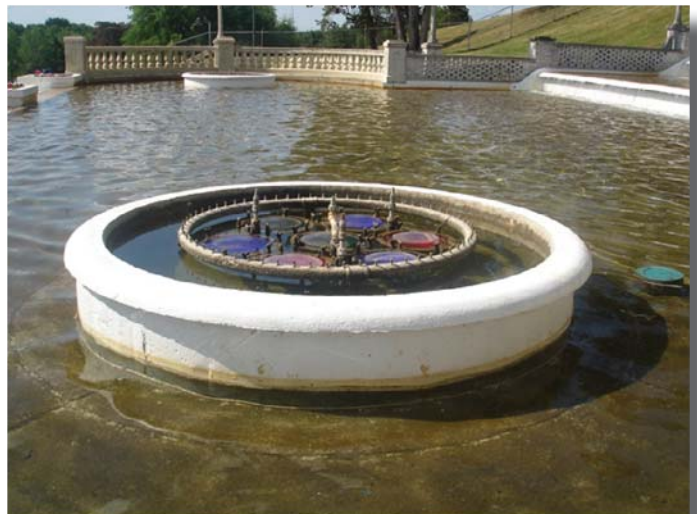
Existing spray fountain (1 of 6)
